# **Vibration Based Crack Detection in a Rotating Disk**

## **Part 2—Experimental Results**

### **Abstract**

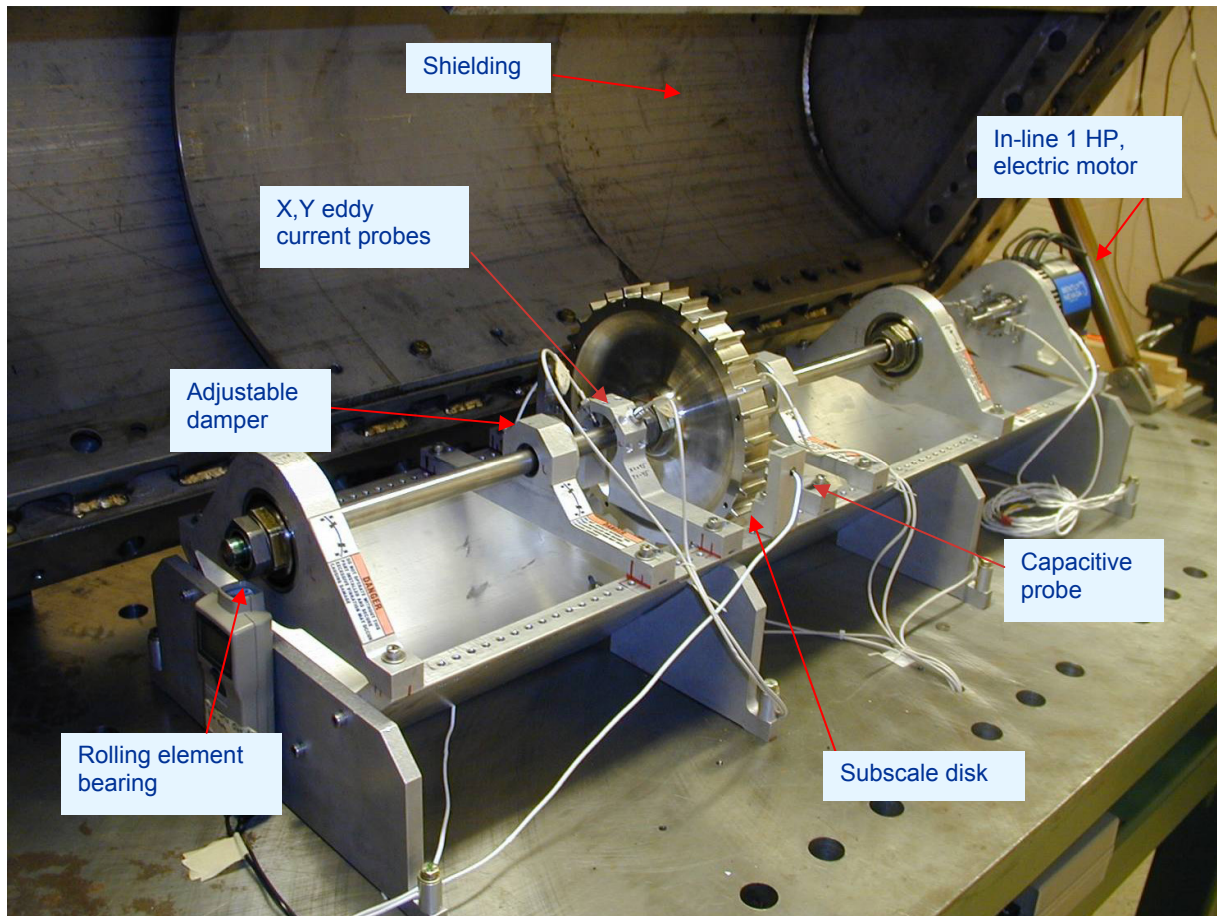
Figure 1 shows the experimental facilities utilized for this study. The system has an adjustable shaft length, and thus, allows one to select an appropriate length to assure operation beyond the system's first critical speed. Here, the maximum length was used based on the rotordynamic calculations of reference 5 that indicated a critical speed of 2610 revolutions per minute (rpm). The stainless steel shaft length and diameter were 30.75 and 0.79 in., respectively. The shaft was supported by precision angular contact ball bearings that were assumed to provide isotropic stiffness. The single disk, as seen in figure 1, was mounted at the mid-span of the shaft. Figure 2 shows a schematic of the disk. The nickel disk was designed to safely handle rotational speeds up to 25000 rpm in the undamaged state. A thinned web area and gear teeth were implemented to imitate the web area and blades of a turbine disk. Note that the gear teeth were also needed due to the fact that the capacitive displacement sensors utilized during experimentation were specially designed, both concerning the hardware and the analysis software, to monitor radial blade tip clearances. The nickel alloy, Haynes X-750, was the material used for the disk. The disk's final design had an outside diameter of 9.25 in. and a bore thickness and outside rim thickness of 1.00 and 1.25 in., respectively. The thinnest portion of the web was 0.10 in., with the cross-section and height dimensions of the blades being 1.25 by 0.13 in. and 0.33 in., respectively. The weight of the disk was 10.75 lbf. Lastly, eight holes, 0.20 in. diameter each, were placed midway in the rim section. The eight holes were spaced every 45 degrees. The holes were designed for future studies as possible mass attachment points or notch initiation sites.

Figure 1.—Rotordynamic test stand.

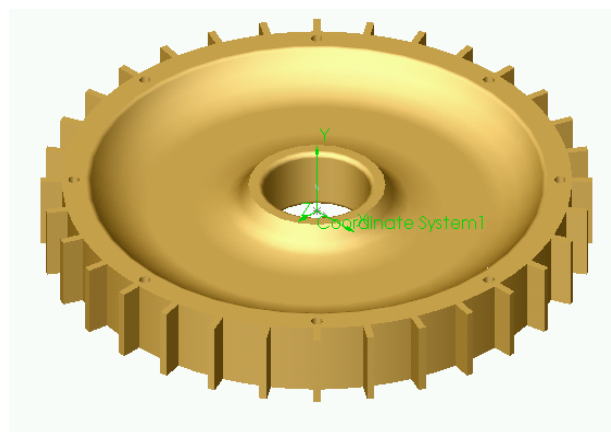
Figure 2.—Schematic of subscale disk.

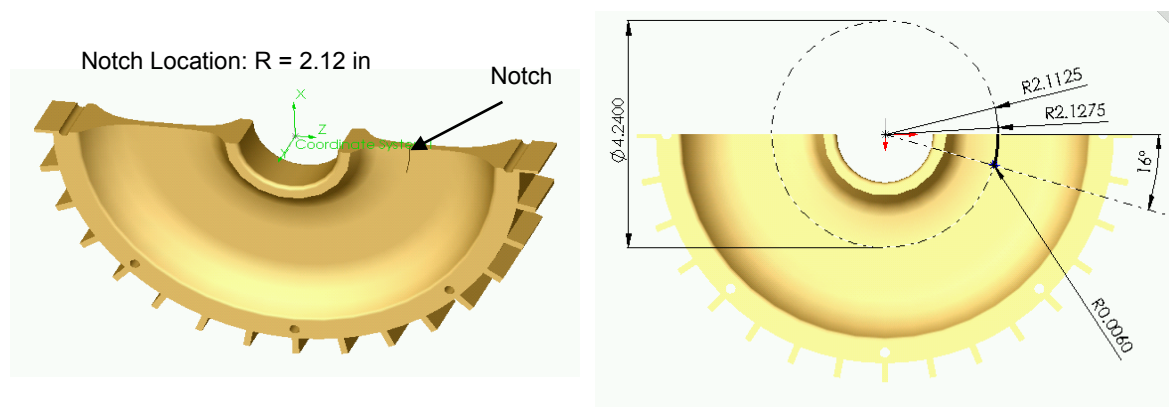
The experimental procedure involved conducting five repetitions of spin-up/spin-down tests with an undamaged disk, followed by five repetitions with a damaged disk (i.e., notched). During the tests blade tip clearance data and shaft vibration data were continuously recorded. The maximum rotational speeds attained were between 5000 and 5400 rpm with acceleration/deceleration rates of 60 rpm/second. Note that the maximum speed was beyond the calculated critical speed of 2610 rpm, thereby guaranteeing post-critical operation. Following the baseline experiments, the disk was removed from the test stand and a 1.2 in. circumferential notch was induced approximately mid-span in the web area using electric discharge machining (EDM). This area was chosen because it had the largest stresses based on the finite element analysis of Part 1 (ref. 5). The notch had a width of 0.015 in. due to the wire thickness and burn area of the EDM process. Careful consideration was given during reassembly so as to maintain the baseline conditions for all system parameters, except of course, for the notch. Various views of the notched disk are shown in figures 3 and 4.

Figure 3.—Schematic showing 1.2 in. circumferential length notch.

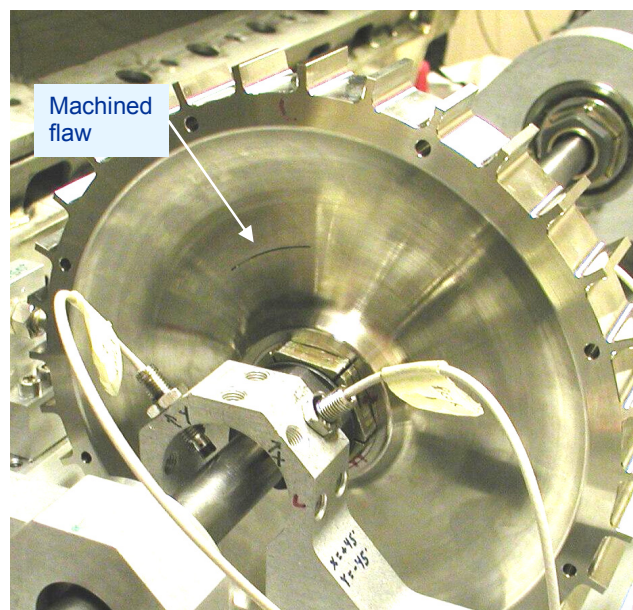
Figure 4.—Image of notched disk

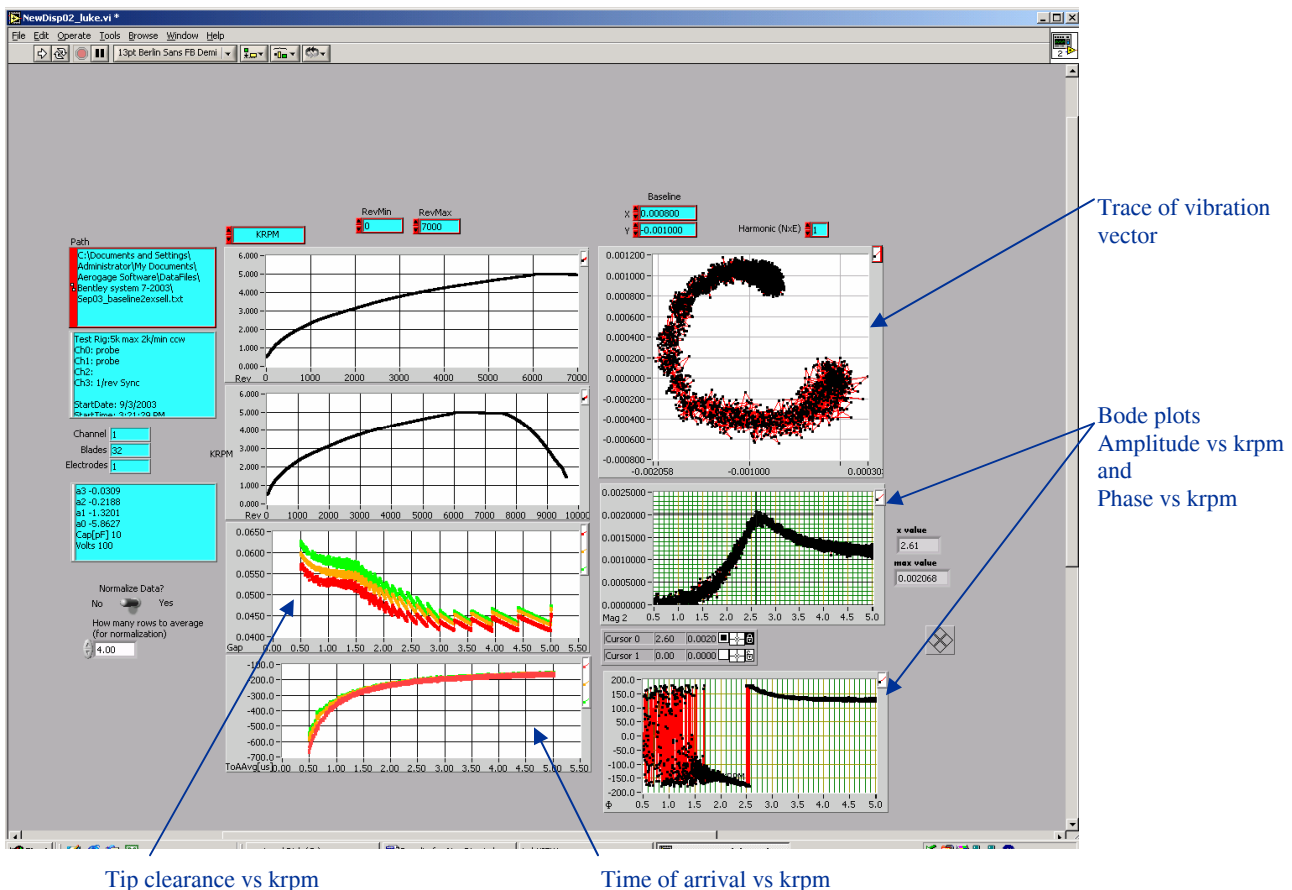
Typical results for the un-notched, baseline case are shown in figures 5 and 6. Figure 5 displays an image of the capacitive probe system's post processing software, while figure 6 represents results from the eddy current probe system. As mentioned in the introduction, shifts in the center of mass are tracked by monitoring the 1-x component of the vibration response. The 1-x component, or first harmonic response, follows the amplitude and phase lag of the synchronous whirl of the rotor system. Changes in the center of mass induce changes in the amplitude and/or phase of the 1-x component. The synchronous whirl behaviors are usually displayed as Bode plots where the amplitude and phase of the system are plotted as functions of rotational frequency. These plots are indicated in figures 5 and 6. Individual blade tip clearance values at multiple rpms are shown in figure 7, again, for a typical baseline test. For the un-notched baseline condition, the rotor's critical speed and the associated maximum amplitude, calculated using the blade tip displacements, were 2614 rpm (standard deviation = 96 rpm) and 0.0021 in. (standard deviation = 0.00011 in.), respectively. Utilizing the eddy current probe data the average critical speed and maximum amplitude were 2332 rpm (standard deviation = 36 rpm) and 0.0031 in. (standard deviation = 0.00021 in.), respectively. The discrepancy between the two sensor systems was probably due to the differences in calculation methodologies, although, the capacitive system's values agreed well with the calculated results (2610 rpm) of Part 1 (ref. 5).

Figure 5.—Typical blade tip clearance data displayed using software associated with the capacitive sensors for the undamaged, baseline disk.

After extracting the post critical 1-x amplitude data from the blade tip clearance measurements (see figs. 5 and 8) for both the baseline and notch tests, a second order polynomial curve fit was conducted using the data. In addition, the statistical significance of the coefficients was calculated. The values of the coefficients as well as their associated statistical significance as represented by the t-values (ref. 7) are shown in table 1. Note that the frequency range of the exported data was 4500 rpm to the maximum speed (between 4900 and 5400 rpm).

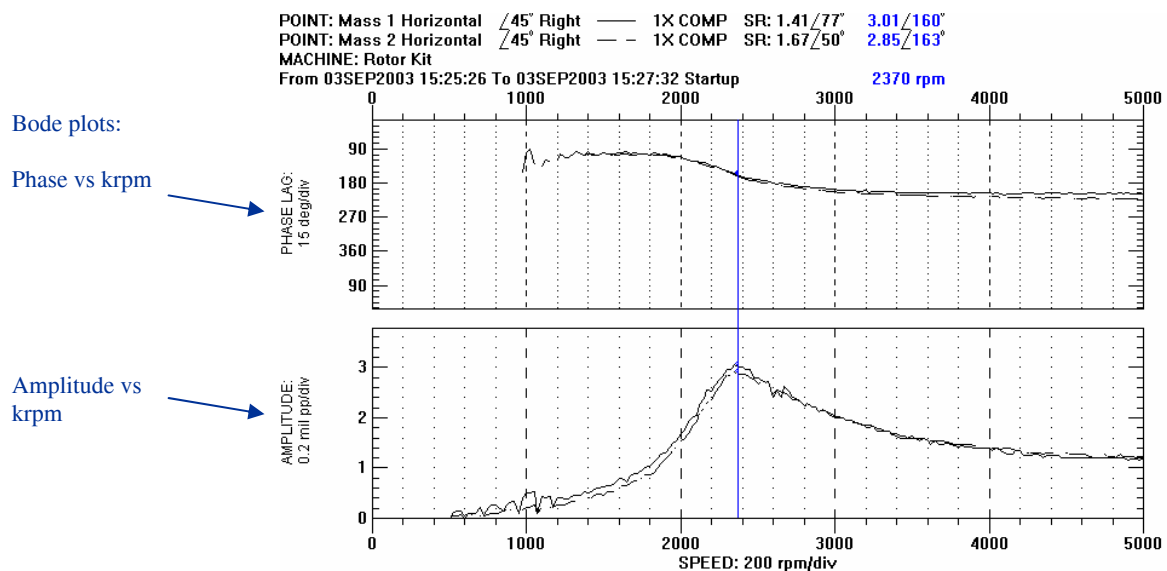
Figure 6.—Bode plots of vibrations displayed using software associated with the eddy current sensor system for the undamaged, baseline disk.

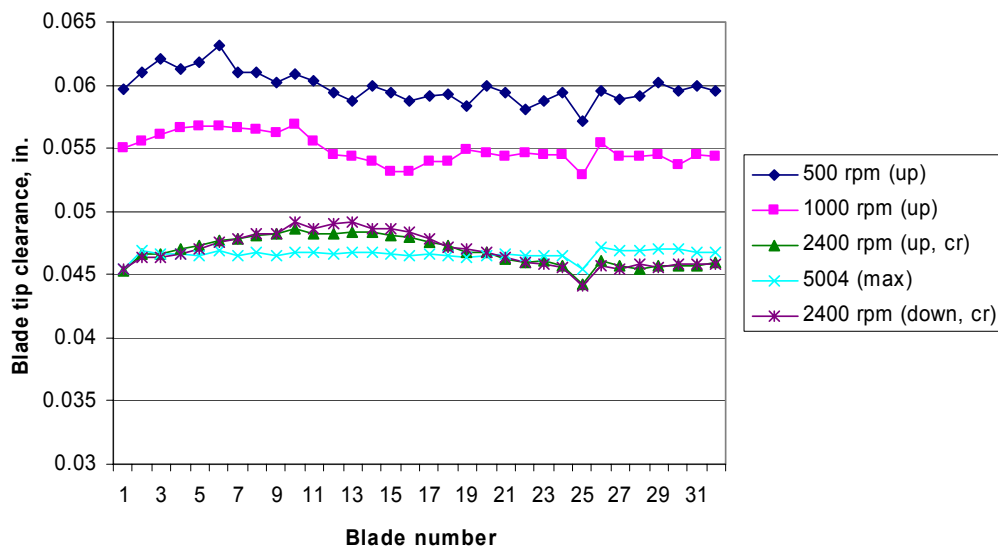
Figure 7.—Blade tip clearance values as a function of rotational speed for a typical baseline test.

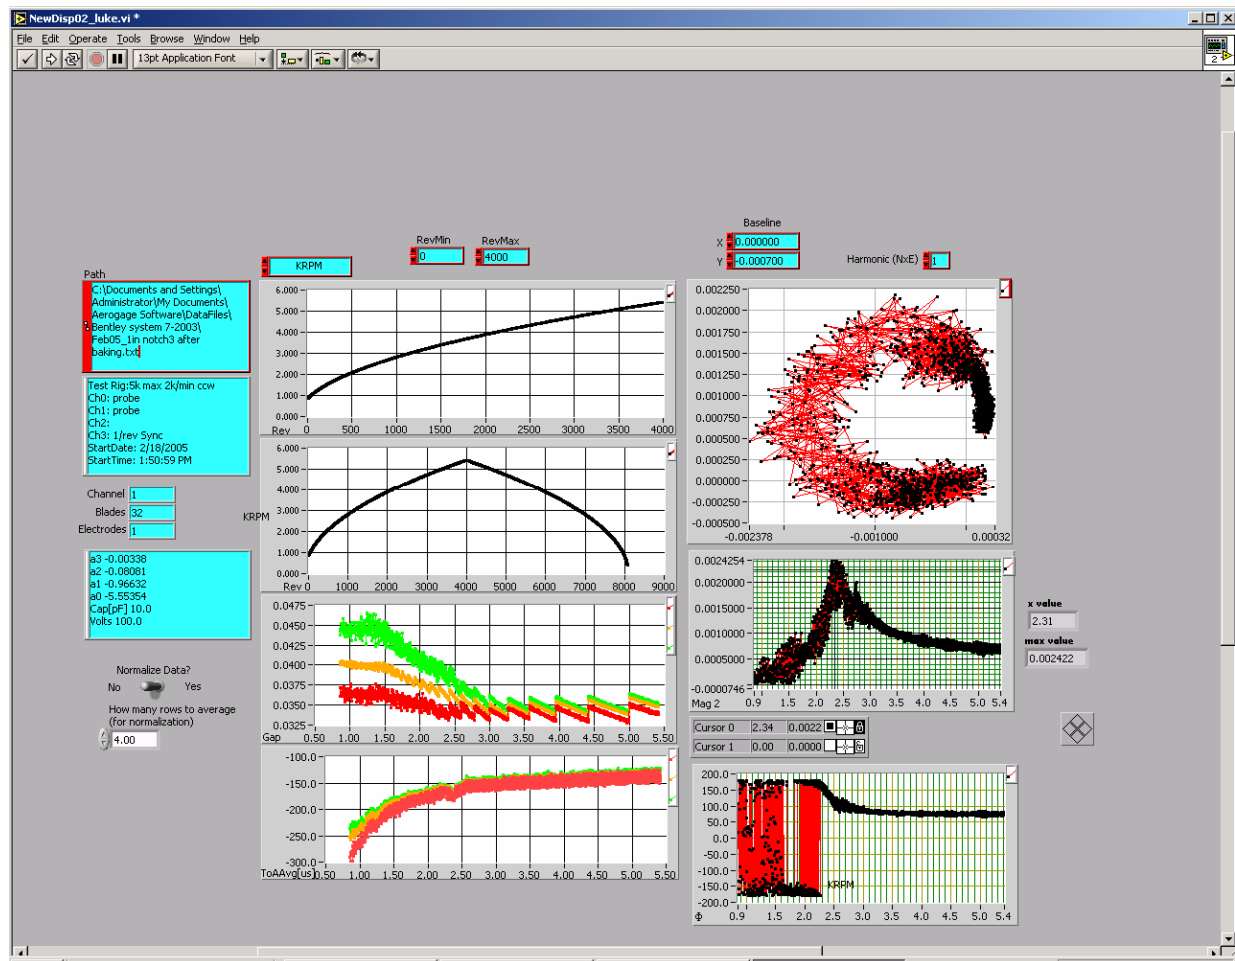
After the introduction of a notch in the disk's web area, the system was carefully reassembled. Typical results for the notched disk are shown in figures 8 through 10. One notable observation included an increase in the noise level concerning the capacitive probe system. This was apparent in the Bode plots as well as the trace of the vibration vector as seen in figure 8. One explanation involved possible mechanical changes in the overall system induced during reassembly. These mechanical changes were indicated by the modifications in the critical speeds and associated maximum amplitudes of whirl as measured by the two sensor systems. The critical speeds and amplitudes of whirl for the system after reassembly were 2658 rpm (standard deviation = 331 rpm) and 0.0018 in. (0.00059 in.) for the blade tip clearance sensor system and 2448 rpm (standard deviation = 61 rpm) and 0.0060 in. (standard deviation = 0.00028 in.) for the eddy current system that was used to monitor the shaft vibrations. Noteworthy were

Figure 8.—Typical blade tip clearance data displayed using software associated with the capacitive sensors for the notched disk.

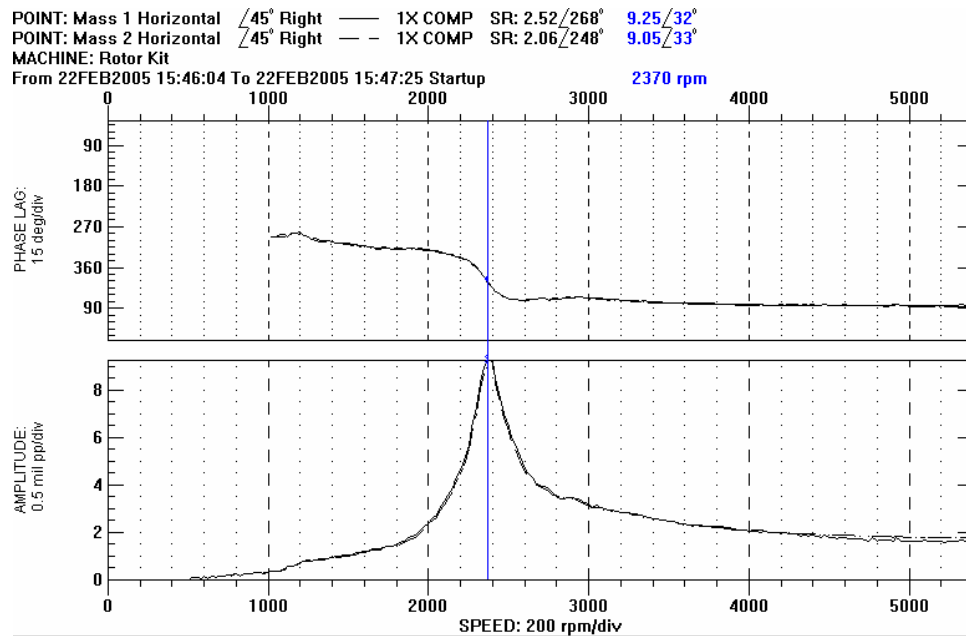
Figure 9.—Bode plots of shaft vibrations displayed using software associated with the eddy current sensor system for the notched disk.

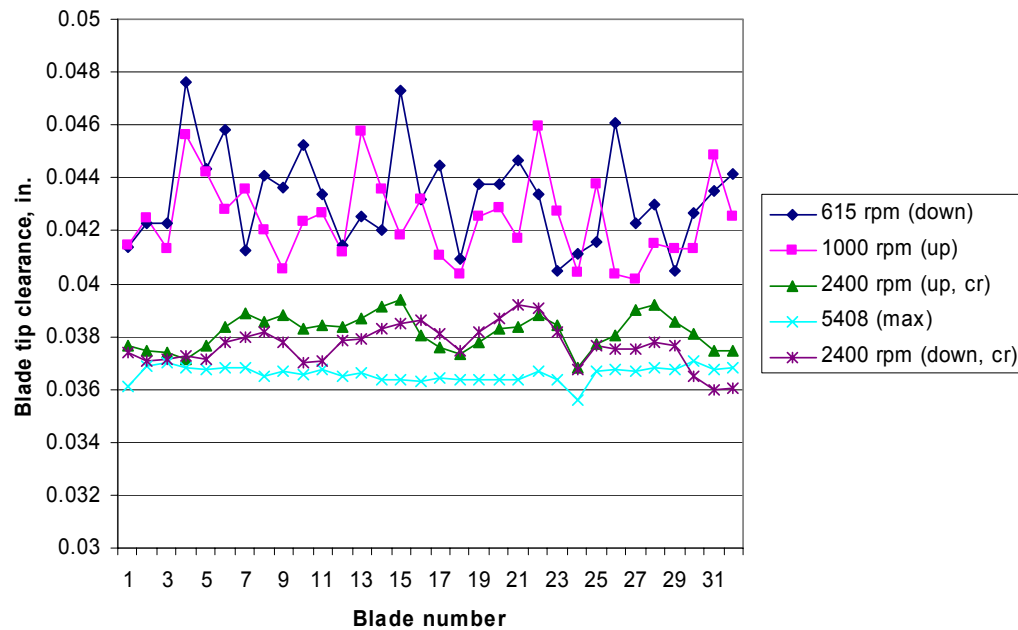
Figure 10.—Blade tip clearance values as a function of rotational speed for a typical notched test.

the increased standard deviations regarding all the values as well as a statistically significant 5 percent increase in the critical speed as measured by the eddy current system. Another noise related observation after reassembly was an apparent choppiness of the blade displacement data in figure 10, especially for rotational speeds below 1000 rpm. Above this speed, the measurements regulated and looked very similar to the baseline tests. Note that in order to obtain better signals regarding the capacitive probe system, the sensors were moved closer for the notched disk tests (compare the offset values in figures 7 and 10). Lastly, during the time frame of the experiments it was discovered that the capacitive probes were sensitive to moisture absorption due to the humidity in the laboratory. As a result, the probes needed to be dried in a low temperature oven and recalibrated prior to each test.

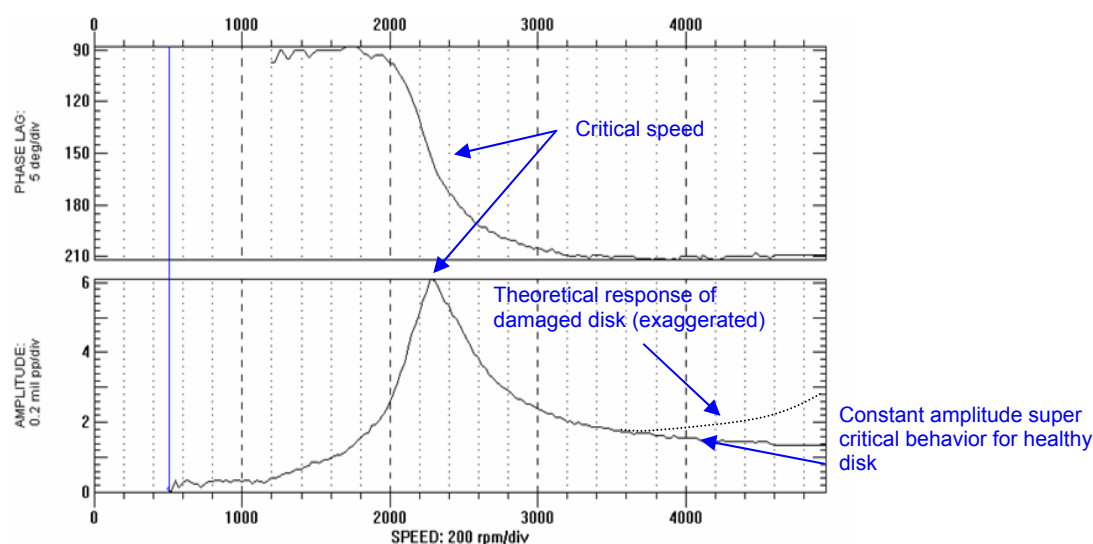
Figure 11.—Exaggerated view of post critical 1-x amplitude behavior (dotted line) of a damaged disk system.

figs. 5 through 10) or rotor response, increases as a function of speed until the critical speed is achieved at which point the amplitude is at its maximum and a 180 degree phase inversion occurs. After the critical speed the system's 1-x amplitude decreases to a level equal to the system's eccentricity and then maintains a constant value even with increasing speed. Note that the eccentricity vector defines the location of the system's center of mass. The maintenance of constant amplitude occurs due to the fact that the rotor now rotates about the system's center of mass. Furthermore, an ideal Jeffcott rotor system defines the eccentricity vector as a fixed constant regardless of rotational speed. For the center of mass based damage detection approach studied here, a crack is assumed to open up as the centrifugal forces increase with speed. Therefore, the shifting of mass as the notch opens causes the eccentricity of the system to change with speed. Figure 11 shows an exaggerated representation of the effects of damage, and the associated speed dependent eccentricity, in the post critical speed domain for the current system.

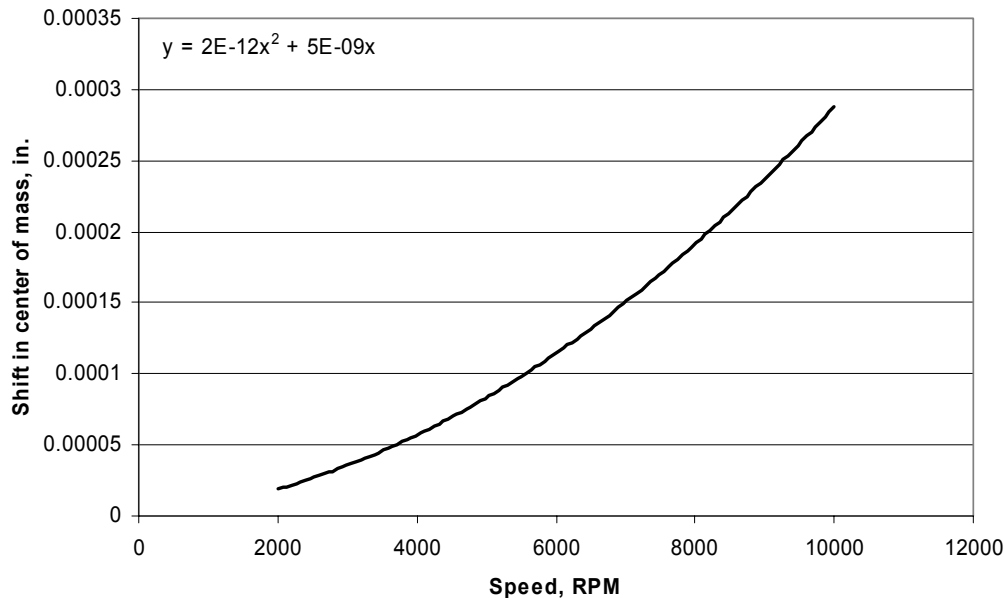
Figure 12.—Finite element analysis results defining amplitude change of the eccentricity vector due to speed dependent opening of a circumferential notch in the web area of the disk (1.2 in. notch). The second order polynomial curve fit of the finite element based results are indicated on the plot.

In Part 1 (ref. 5), FE based analyses defined the change in center of mass (i.e., a change with respect to an initial undamaged value) for the disk as a function of notch size and speed. Figure 12 shows the analysis results for the particular 1.2 in. notch employed here. The change in amplitude as a function of frequency was shown to be a second order polynomial as indicated in the figure (units: in. and rpm). Note that the coefficient values were very small and difficult to measure experimentally. Furthermore, at this point no effort was made to define the disk's initial eccentricity vector (amplitude and phase), hence, the values of the particular coefficients describing the shift/change in the center of mass were values observable only if the changes due to the notch were in-phase with the disk's eccentricity vector (causing increasing amplitude). The coefficients would be different if the phase difference between the initial eccentricity vector and the change vector was something other than zero degrees. Therefore, the approach taken here was to analyze the post critical 1-x amplitude behavior regarding the experimental data and search for a statistically significant coefficient for the  $\omega^2$  term that would only be present due to a speed dependent eccentricity vector resulting from a notch. Because the blade tip clearance system utilized modifiable, in-house software, data was easily exported for further analysis of the post critical amplitude behavior. This was not the case for the eddy current measurement system used to monitor the shaft vibrations.

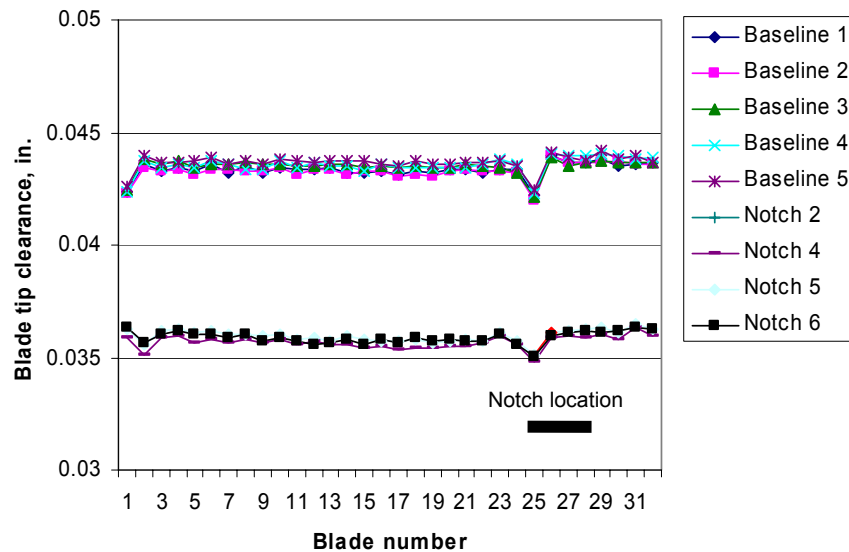
Next, comparisons of blade displacement behaviors between the baseline and notched cases were conducted as seen in figures 13 and 14. Multiple data sets were grouped together in an effort to see any unusual deformation behavior in the vicinity of the notch. Note that the notch was circumferentially located in the vicinity of blades 25 through 28 as indicated in figures 13 and 14. Typical subtraction results (= baseline – notch) are shown in figure 14. No obvious patterns were seen in either plot that indicates additional extensions of the affected blades (i.e., blades 25 through 28).

Figure 13.—Comparison of blade tip clearance values at 4900 rpm. The notch location is indicated in the plot.

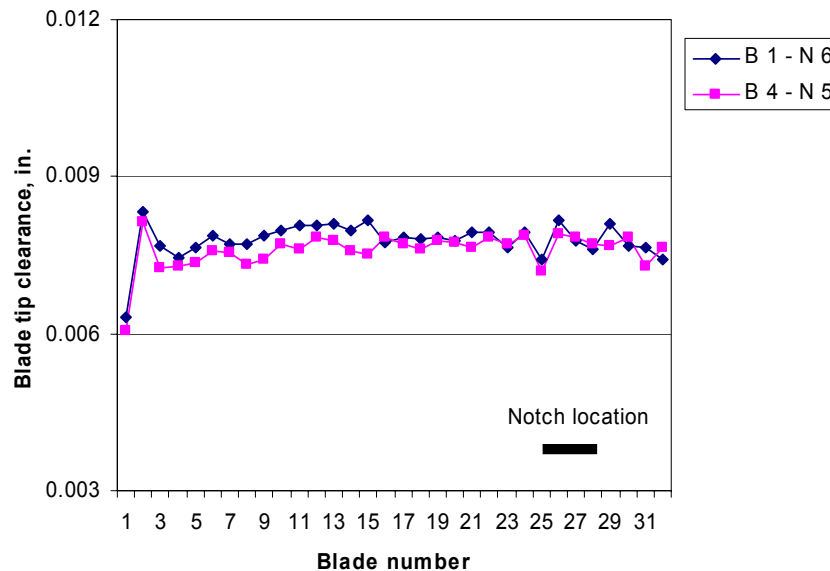
Figure 14.—Typical results regarding the subtraction of notch test results from baseline results at 4900 rpm.
